# Morphology of Micropitting

R. L. Errichello

Understanding the morphology of micropitting is critical in determining the root cause of failure. Examples of micropitting in gears and rolling-element bearings are presented to illustrate morphological variations that can occur in practice.

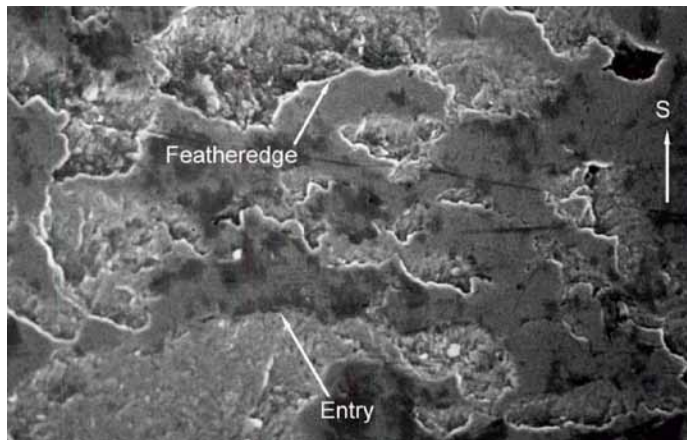
Figure 1 SEM image of micropitting.

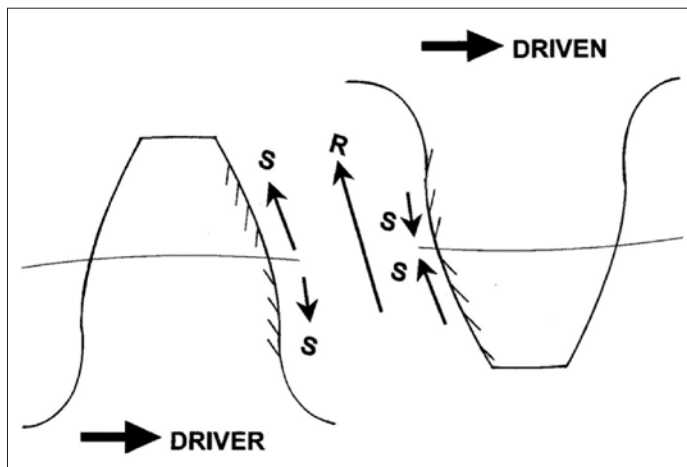
Figure 2 shows the directions of the rolling (R) and sliding (S) velocities on the driving and driven gear teeth. Contact on the driver tooth starts near the root of the tooth, rolls up the tooth, and ends at the tooth tip. Sliding is away from the driving gear pitch line. Contact on the driven tooth starts at the tooth tip, rolls down the tooth, and ends near the tooth root. Sliding is towards the driven gear pitch line. Like macropitting, micropitting cracks grow opposite the direction of sliding at the gear tooth surface. Consequently, the cracks converge near the pitch line of the driver and diverge near the pitch line of the driven gear.

Figure 2 Rolling (R) and sliding (S) directions.

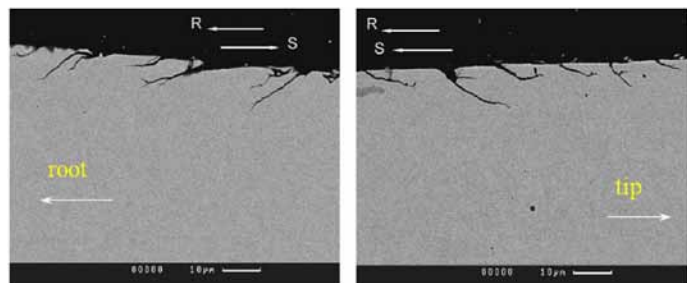
Figure 3 shows metallurgical sections cut transversely through micropits that show cracks start at or near the gear tooth surface and grow at a shallow angle (typically 10–30°, but sometimes as steep as 45°) to the surface.

Figure 3 Micropitting cracks on a driven gear (courtesy of Newcastle University).

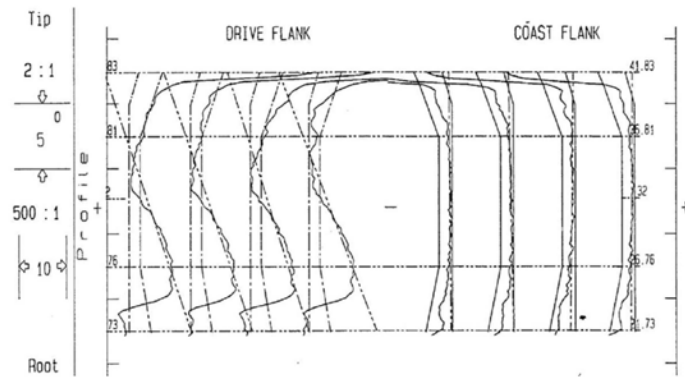
Figure 4 shows profile inspection charts that demonstrate typical profile damage due to micropitting on the drive flanks of a wind turbine high-speed (HS) pinion.

The charts for the coast flanks show the original accuracy of the pinion was high, but the micropitting caused severe deterior-

ration of the drive flanks. Note that the entire active drive flanks were damaged, but the damage was most severe in the dedenda in the area of negative sliding.

Figure 4 Typical profile damage due to micropitting on wind turbine HS pinion.

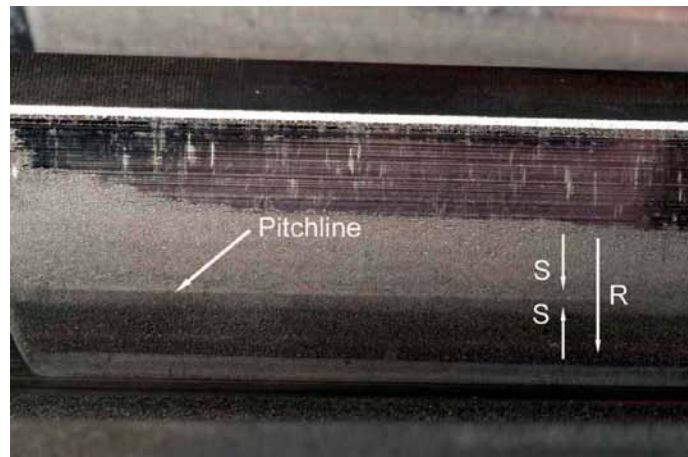
Figure 5 shows a form-ground wind turbine intermediate (INT) pinion with micropitting that crosses the pitch line.

Because slide directions reverse as the pitch line is crossed, micropitting cracks grow in opposite directions above and below the pitch line. Figure 5 shows that when micropitting grows across the pitch line, it makes the pitch line readily discernible because opposite inclinations of the floors of micropit craters scatter light in opposite directions above and below the pitch line.

Figure 5 Pitch line is readily discernible on a driven wind turbine INT pinion.

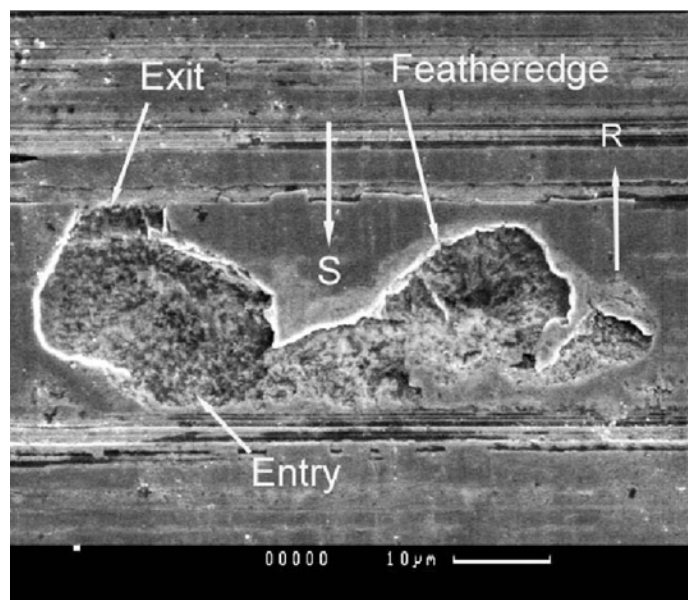
Figure 6 is an SEM image of micropitting on a high asperity of a ground tooth surface.

Micropitting begins by attacking high points on gear tooth surfaces such as crests of undulations, peaks of cutter scallops, ridges of grinding lay, and edges of grinding scratches. Figure 6 shows the surface of the asperity has been severely plastically deformed. Tractional stress from sliding has caused material to flow over the micropit craters and form a featheredge at the exit side of the craters. Growth of the micropits is opposite to the slide direction and begins at the entry (first point reached by the roll direction) and ends at the exit (last point reached by the roll direction).

Figure 6 SEM image of micropitting on asperity peak of ground tooth surface (courtesy of Newcastle University).

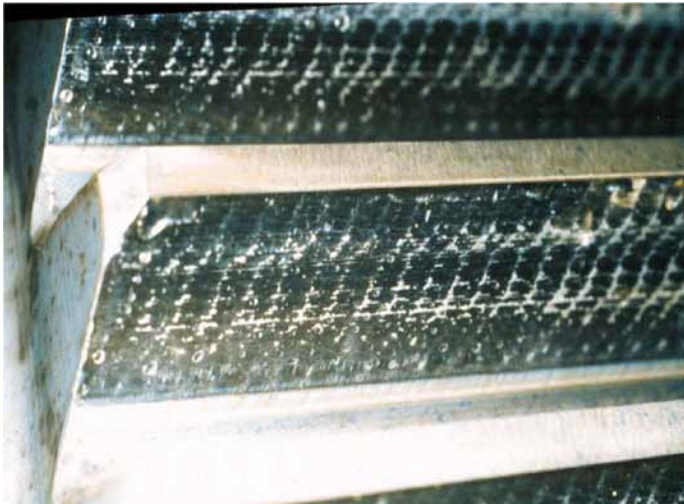
Figure 7 shows a skive-hobbed wind turbine low speed (LS) wheel with micropitting on peaks of the hob scallops. Figure 8 shows a form-ground wind turbine INT wheel with micropitting on peaks of longitudinal grind scratches. Multiple cracks originate at these sites and coalesce to form micropits along lines that follow high points of surface topography. If ridges are periodic, micropitting might form in regularly spaced rows. Micropitting generally progresses until surface peaks are removed, and might continue until large areas of tooth surface become porous and continuously cracked.

**Figure 7** Wind turbine LS wheel with micropitting on peaks of hob scallops.

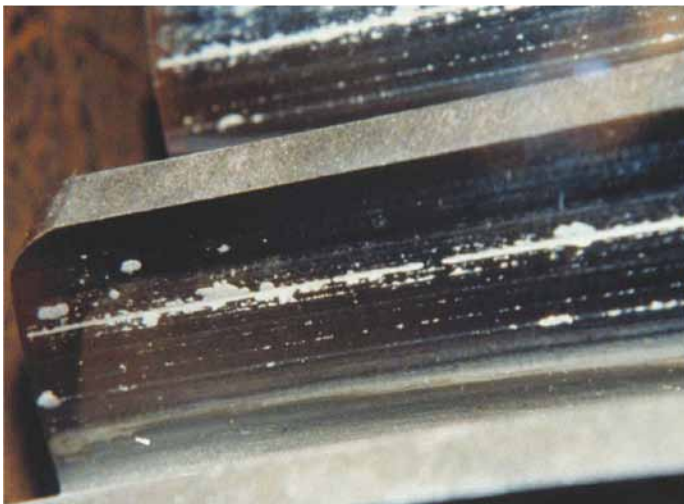
Figure 8 shows a form-ground wind turbine INT wheel with micropitting on peaks of longitudinal grind scratches.

**Figure 8** Wind turbine INT wheel with micropitting on peaks of grind scratches.

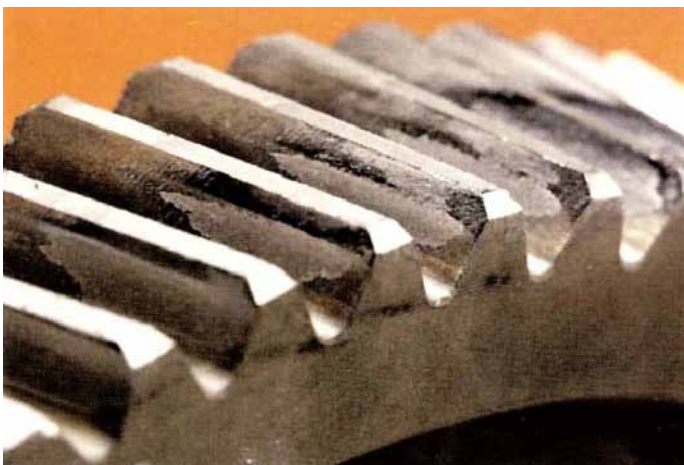
If the pinion and wheel were initially accurate and had little run-out, micropitting damage might be similar from tooth-to-tooth. In these cases micropitting patterns can be interpreted in much the same way contact patterns are used to assess gear tooth alignment and load distribution. For example, Figure 9 shows a helical wheel that had some misalignment.

**Figure 9** Micropitting pattern on a helical wheel that had some misalignment (courtesy of Caterpillar).

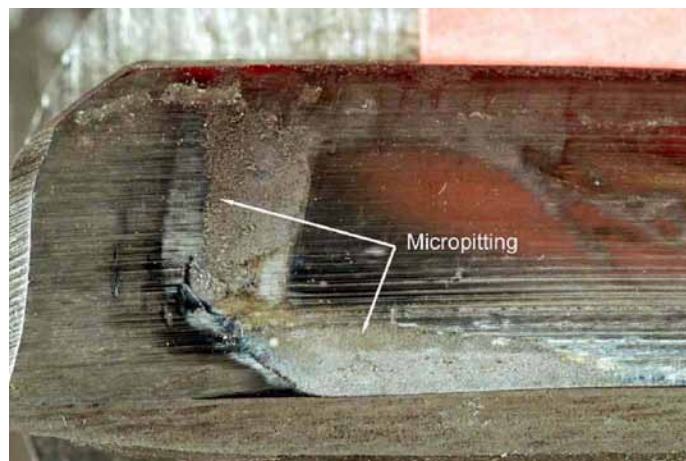
Figure 10 shows a form-ground wind turbine HS pinion with micropitting at the edge of contact at the drive end of the active face width.

Figure 10 Wind turbine HS pinion with micropitting at edge of contact.

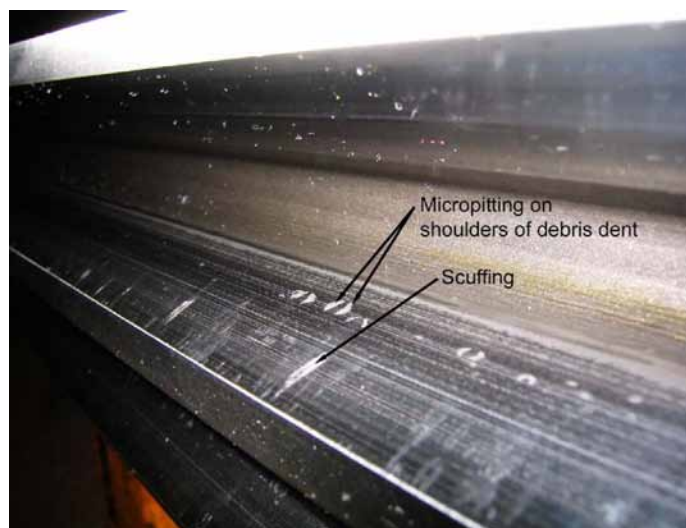
Figure 11 shows a form-ground wind turbine sun pinion with micropitting on shoulders of debris dents. Debris dents are local depressions that cause loss of EHL film thickness and lead to GSC at shoulders of dents. Cyclic contacts at these sites generate pressure spikes, plastic deformation, and tensile residual stresses that eventually initiate micropits.

Figure 11 Wind turbine sun pinion with micropitting on shoulders of debris dents.

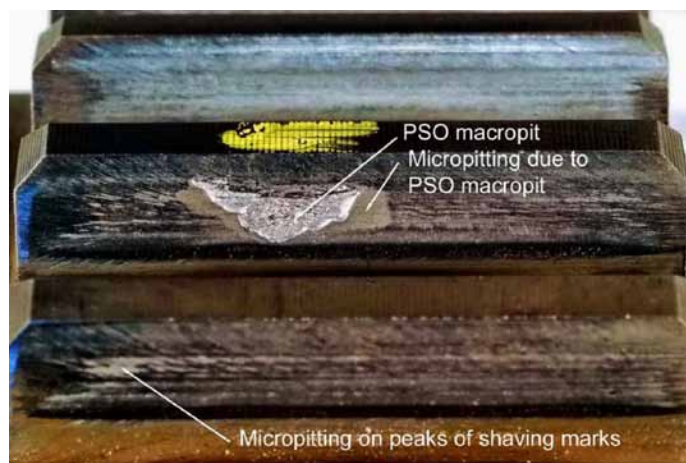
Figure 12 shows a shaved automotive planet wheel. In addition, Figure 12 shows micropitting at edges of a PSO macropit. It is a secondary failure mode that occurred because the PSO macropit disrupted the EHL lubricant film. Other teeth show there is also micropitting on peaks of the shaving marks.

Figure 12 Micropitting at edges of PSO macropit on shaved automotive planet.

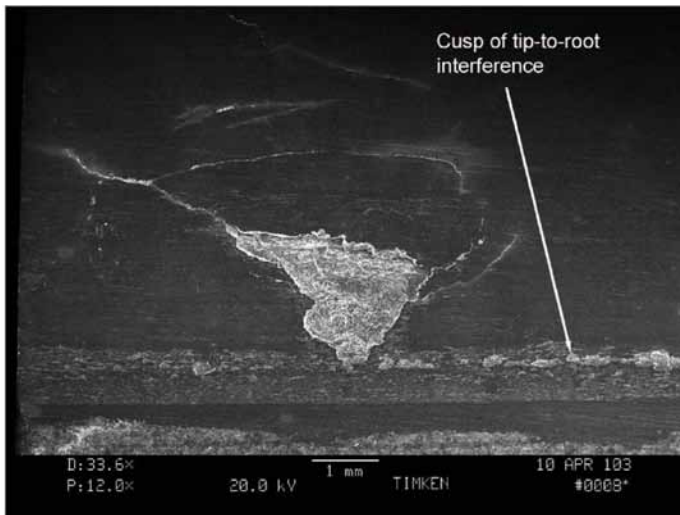
Figure 13 shows a FZG PT-C pinion with a PSO macropit that initiated at the cusp above tip-to-root damage at the SAP.

The root cause of the PSO macropit shown in Figure 13 is GSC caused by tip-to-root interference (Ref. 3). The FVA micropitting test (Ref. 4) requires the test to be terminated when a macropit occurs.

Figure 13 FZG PT-C pinion with PSO macropit starting from GSC at SAP (courtesy of Afton Chemical).

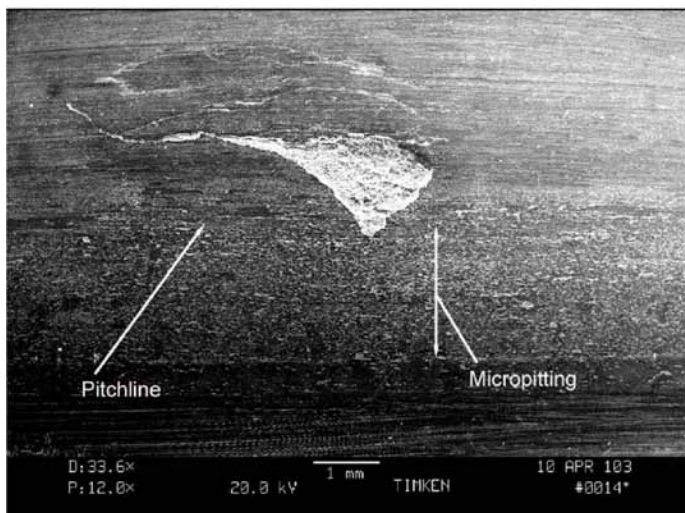
Figure 14 shows a FZG GF-C pinion with a PSO macropit that initiated at the upper edge of a 2 mm-high band of micropitting.

The root cause of the PSO macropit shown in Figure 14 is GSC caused by micropitting (Ref. 5).

Figure 14 FZG GF-C pinion with PSO macropit starting from GSC near pitch line (courtesy of Afton Chemical).

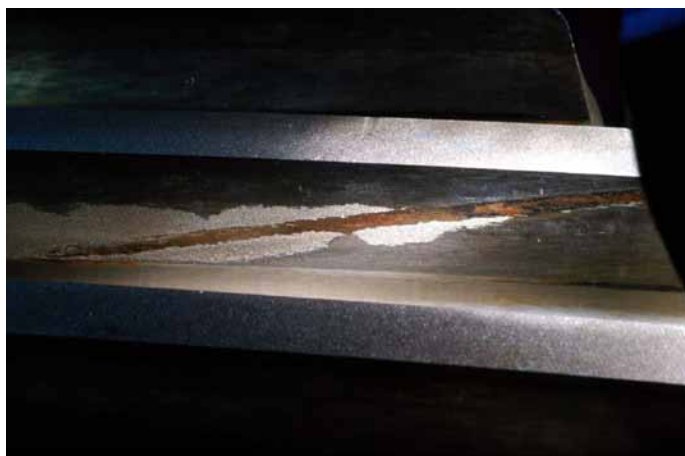
Figure 15 shows a contact line with fretting corrosion on a wind turbine INT wheel, as well as micropitting at edges of the fretting line. The fretting corrosion occurred when the wind turbine was parked; the micropitting occurred later during operation due to GSC at the edges of the fretting line. Therefore, fretting corrosion was the primary failure mode and micropitting was a secondary failure mode.

Figure 15 Wind turbine INT wheel with micropitting at edges of fretting line.

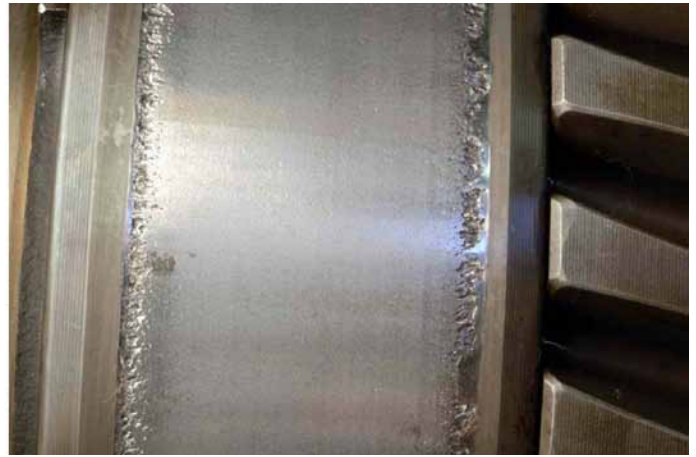
Figure 16 shows micropitting on the inner ring (IR) of a cylindrical roller bearing (CRB) from a wind turbine HS pinion. The micropitting reduced the diameter of the IR, increased the bearing internal clearance, increased the roller loads, and increased stresses. Furthermore, the micropitting caused the IR to conform to the rollers and negate the crown of the rollers. This caused GSC at the ends of the rollers and resulted in macropitting at each end of the raceway. Therefore, micropitting was the primary failure mode and GSC macropitting was a secondary failure mode.

Figure 16 Micropitting on CRB IR of wind turbine HS pinion.

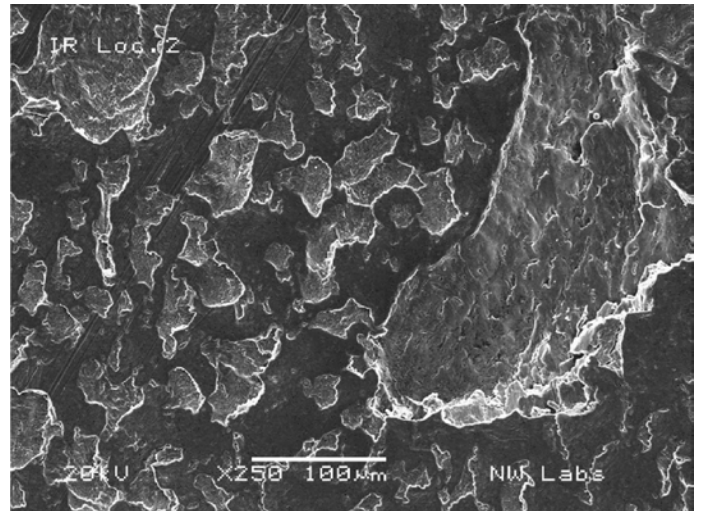
Figure 17 is an SEM image of the central part of Figure 16, showing an enlarged view of the micropitting.

Figure 17 shows that micropitting in rolling-element bearing components has a directional randomness that differs from the more directionally oriented micropitting that is typical in gear teeth. This is probably caused by differences in sliding directions, which are more random in rolling-element bearings than in gears.

Figure 17 SEM image of micropitting on pinion (courtesy of Northwest Labs).

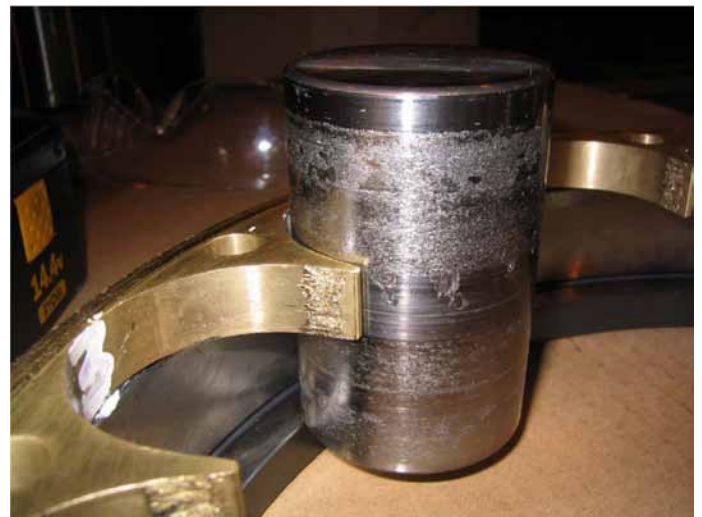
Figure 18 shows a roller from a CRB from a wind turbine INT pinion. The roller has scuffing in two circumferential bands that were caused by skidding between the roller and the outer ring (OR) raceways.

The bearing has a disc-shaped cage that is guided by a groove in the two-piece OR. No contact occurs between the roller and OR raceway in the central portion of the roller because the OR raceway is interrupted by the cage groove. Consequently, no scuffing occurred in the central portion of the roller. Furthermore, the roller has end-reliefs that prevented scuffing at the roller ends.

Figure 18 Scuffing on CRB roller from wind turbine INT pinion bearing.

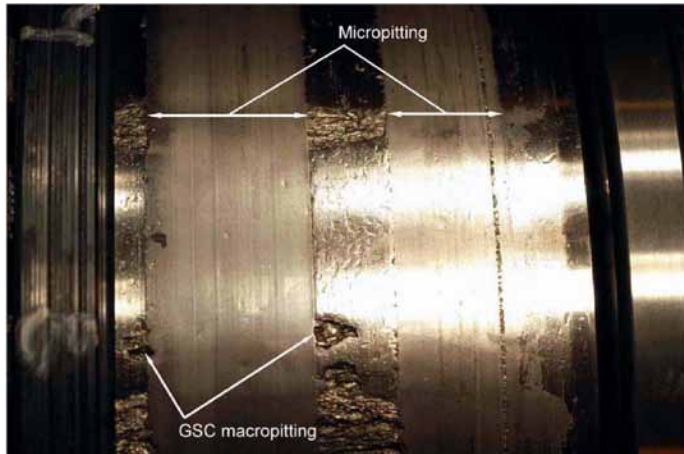
Figure 19 shows a CRB IR from a wind turbine INT pinion that mated with the roller shown in Figure 18.

Figure 19 shows micropitting that occurred in two circumferential bands—separated by a central band without micropitting. The two bands of micropitting were caused by the scuffing-induced roughness on the rollers. There is also a band without micropitting at each end of the active raceway; GSC macropitting occurred on the left and central bands.

of the load-bearing area of the IR raceway was lost, leaving only the central part of the raceway and two ends to support load; this in turn led to the GSC macropitting (Fig. 19).

This example demonstrates a complex series of failure modes that started with scuffing between the rollers and OR raceway; this was followed by micropitting on the IR raceway caused by the rough surfaces of the scuffed rollers, and, finally, GSC macropitting on the IR caused by GSC due to micropitting. Therefore, scuffing was the primary failure mode and micropitting and GSC macropitting were secondary failure modes.

Figure 19 Micropitting on CRB IR from a wind turbine INT pinion bearing.

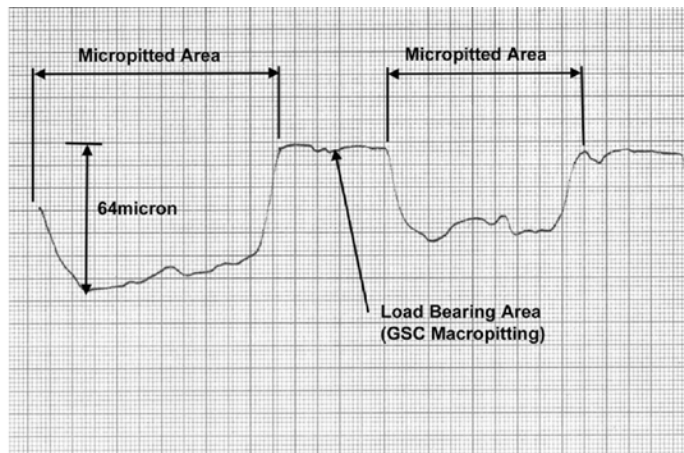
Figure 20 is a plot of the axial profile of the IR shown in Figure 19.

Figure 20 shows the micropitting caused two ruts in the raceway that are up to 64  $\mu\text{m}$  deep. Consequently, a major portion

Figure 20 Axial profile of CRB IR from wind turbine INT bearing.

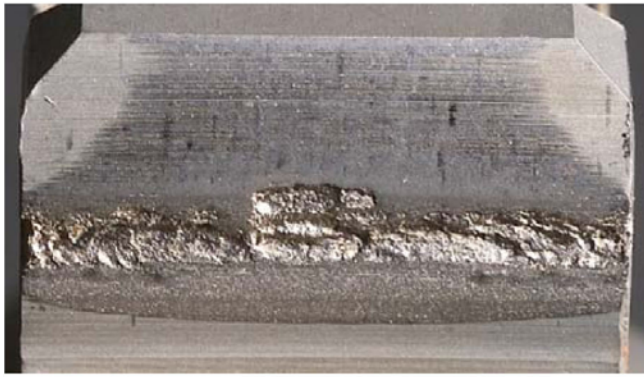
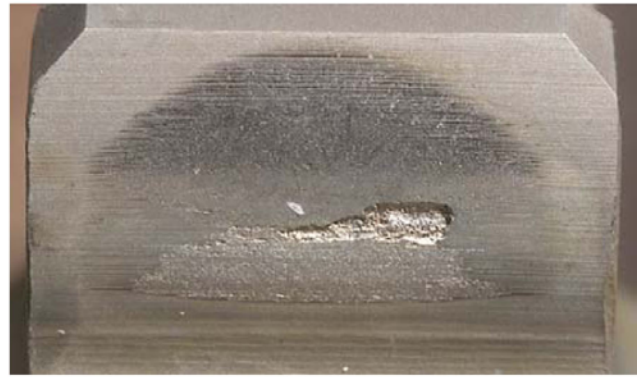
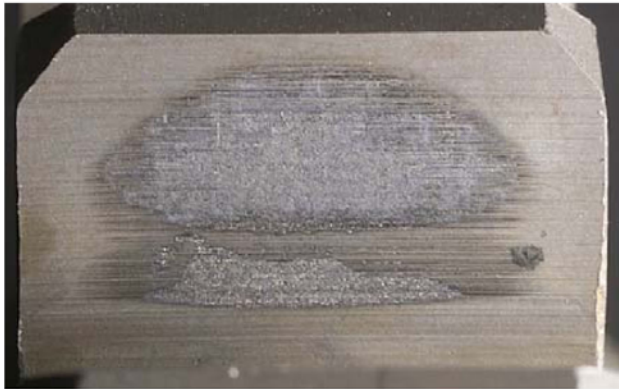
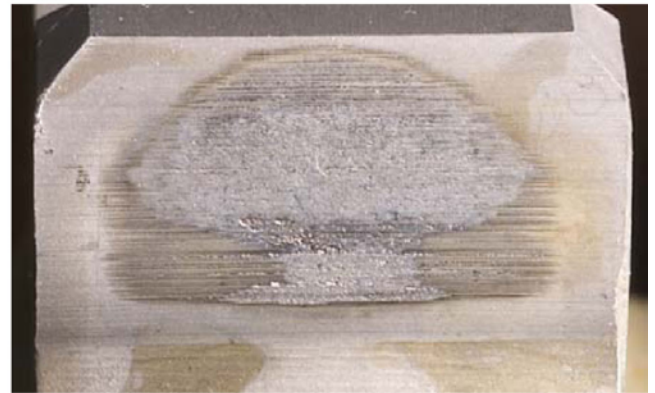
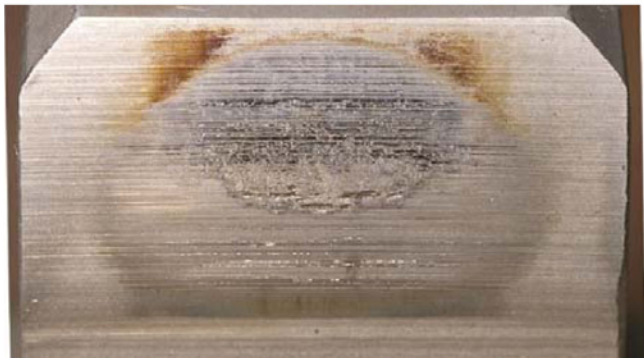
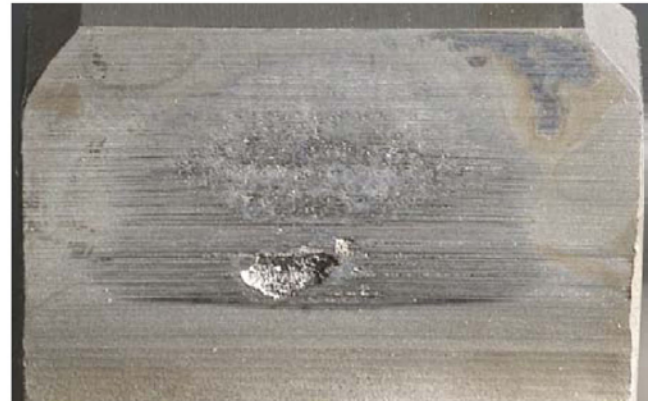
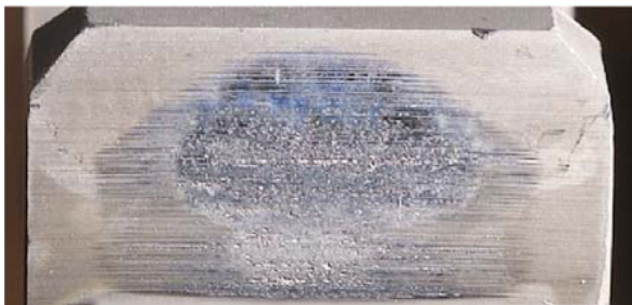
Figure 21 Influence of oil type on micropitting (courtesy of ExxonMobil).

Figure 21 shows the influence of oil type on micropitting. The test results were obtained with AGMA test gears (Ref. 7). The pinion and wheel have tip relief, and the pinion has a crown that limits the size of the contact pattern.

Figure 21 shows Oil-A had the lowest micropitting resistance and Oil-E had the highest micropitting resistance. Oil-A and Oil-B initiated macropitting due to GSC at the top of the micropitting band. Oil-F had the second-best micropitting resistance, but a PSO macropit initiated due to GSC caused by tip-to-root interference.
